Inadvertent Removal of a Right Ventricular Pacemaker Lead by a Knotted Transvenous Pacing Wire

Indian Journal of Critical Care Medicine (2019); 10.5005/jp-journals-10071-23126

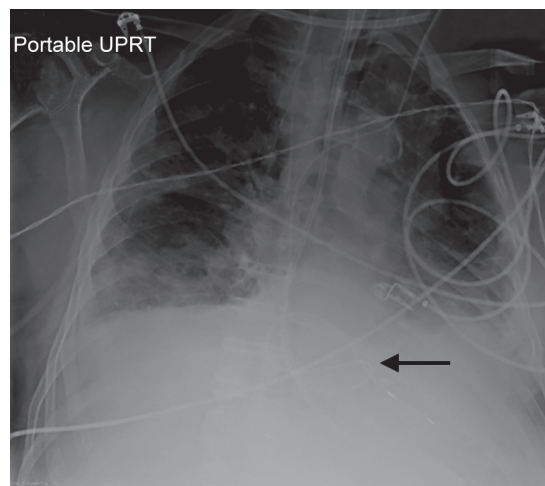
A 79-year-old male with a history of chronic obstructive pulmonary disease, type 2 diabetes, chronic kidney disease, and persistent atrial fibrillation was brought to hospital after being successfully resuscitated following a brief pulseless electrical activity (PEA) cardiac arrest. During his convalescence, he had a second PEA arrest, from which he was again successfully resuscitated. Telemetry revealed atrial flutter with atrioventricular conduction that slowed markedly to ventricular rates as low as 34 beats per minute. A balloon-tipped temporary pacing catheter was floated in via left internal jugular vein until adequate ventricular capture was observed. Fluoroscopy was not used during insertion. A follow-up chest X-ray confirmed appropriate placement of the lead, which revealed the lead in the right ventricle with redundant lead slack forming a loop (Fig. 1).

Fig. 1: Following TVP insertion, the looped lead is visible in the RV on chest X-ray (arrow)

This case illustrates that care must be taken when removing a TVP lead following PPM implantation, and underscores the fact that suboptimal TVP lead placement, such as looping in the RV, can result in complications. Such loops may be avoided by placement of TVP under fluoroscopy if feasible. If such loops are discovered subsequently, as in this case, attempts to reduce the loop may prevent such complication.

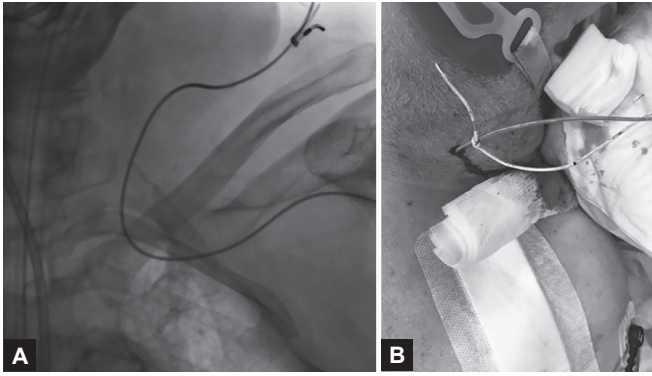
Figs. 2A and B: The snared RV lead is visible fluoroscopically before (A) and photographically after (B) inadvertent removal through the skin overlying the left internal jugular vein

removed. It quickly became evident that the reason for the resistance was that the TVP lead had looped and formed a knot around the RV PPM lead at the junction of the left subclavian and left internal jugular vein. Continued traction had thus dislodged the RV lead tip from the endocardium, resulting in inadvertent removal of the RV lead through the left internal jugular vein (Fig. 2). No dislodgement of the PPM lead had been apparent fluoroscopically during removal of the TVP wire from the cardiac silhouette as the ensnarement occurred at the level of the thoracic inlet when fluoroscopy was no longer being employed, and no loss of capture was noted as the patient was in their intrinsic rhythm. The patient remained hemodynamically stable.

In order to place a new RV PPM lead, left axillary venous access was obtained and a new lead was successfully placed, which was connected to the original pulse generator. The ensnared RV lead was cut within the pocket, and the lead pin was removed from the pulse generator directly. The external portion of the RV lead (Fig. 2B) was then removed without complication from the left internal jugular vein. The new PPM assembly functioned well, and the procedure was completed without any further complication.

If a loop in a TVP is identified during PPM implantation, then reduction of the loop should be performed prior to introduction of a permanent pacing lead. Alternatively, the TVP loop should be closely observed during TVP removal to ensure that a knot does not form around the pacing lead. In this case, despite careful fluoroscopic observation during TVP removal, snaring and removal of the PPM lead still occurred. This illustrates the importance of prevention and reduction of such loops, if possible.
